Church Rock Uranium Monitoring Project 2003-2007

REPORT OF THE CHURCH ROCK URANIUM MONITORING PROJECT 2003-2007

CHURCHROCK CHAPTER, NAVAJO NATION Church Rock, New Mexico

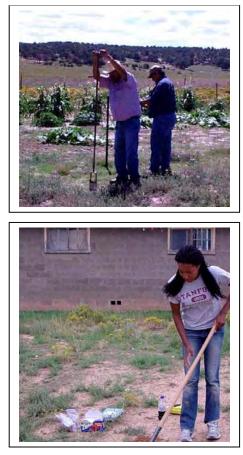
Figures IV.1a and IV.1b Soil sampling techniques

surface. A hand auger borrowed by the New Mexico Environmental Department was used to obtain samples between the immediate surface of the ground (Figure IV.1a). A shovel was used to collect surface soil samples (Figure IV.1b). In all, more than 100 soil samples were collected from a dozen sites in the region.

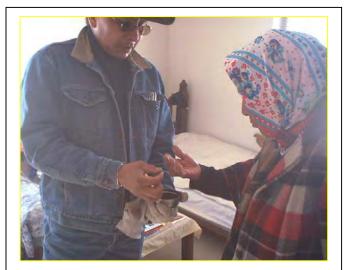
Figure V.1. NNEPA's John Plummer explains the purpose of charcoal in an indoor radon canister to a Churchrock-area resident.

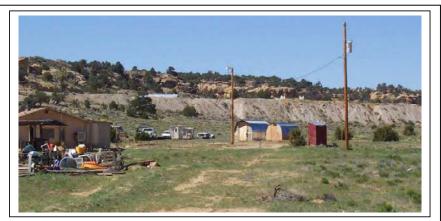
Figure VII.2. This home on Red Water Pond Road is located within 500 feet of the NECR Mine waste dump.

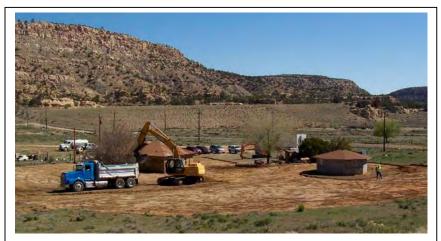
Figure VII.3. Radium-contaminated soils are excavated from around these homes on Red Water Pond Road in May 2007. The reclaimed Church Rock I Mine site forms the ledge in the middle background.
