# HYDRO-RAKING AS A MANAGEMENT OPTION FOR AQUATIC NON-NATIVE INVASIVE AND NATIVE NUISANCE PLANTS IN FRESHWATER PONDS AND LAKES: CASE STUDIES IN MASSACHUSETTS

**MAY 2016**

**A THESIS**

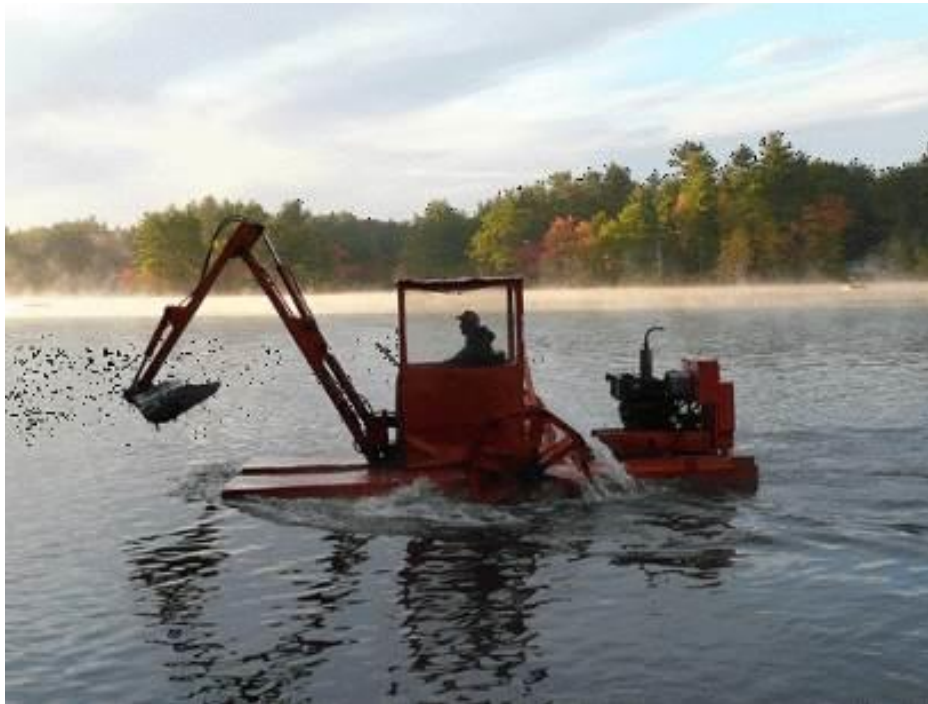
Figure 1. Hydro-raking machinery with seated driver (Foster's Pond Corporation, 2007).

Hydro-raking is a mechanical means of managing non-native invasive and native nuisance plants by utilizing a pontoon boat with paddlewheels, with a large rake attached to a crane arm, operated by a seated driver, as seen in Figure 1. The machine rakes plant material (living or non-living), leaf litter and other organic debris, from pond and lake bottoms to improve habitat, water quality, aesthetics and nutrient control.

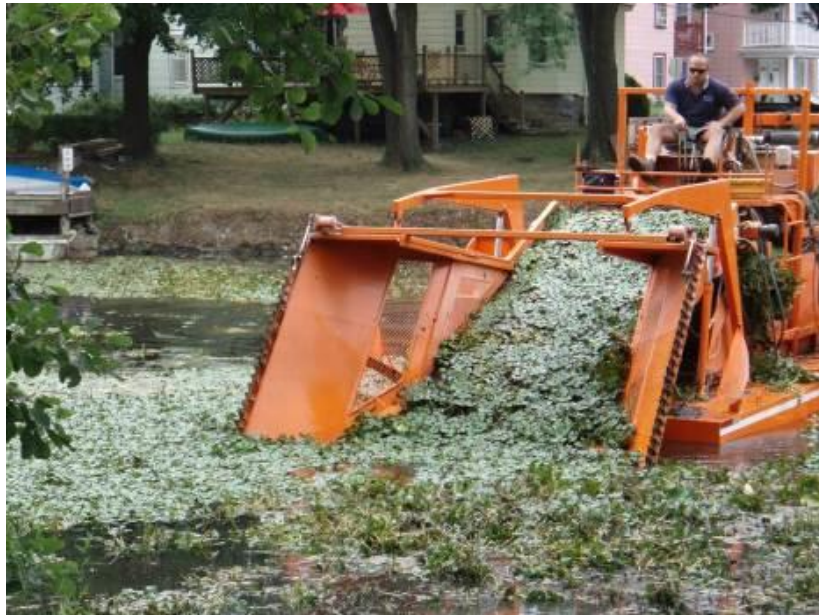
Figure 2. Harvester gathering plants onto conveyor belt. Photo credit: (Mystic River Watershed Association, 2010)

A mechanical harvester, seen in in Figures 2 and 3, so not to be confused with a hydro-rake, will be explained in detail more than the other management options. The operations of a harvester differ from the hydro-rake through the cutting the plants below the water with a giant saw. The plants are then brought up on a conveyor belt similar, to a treadmill, where the plants are then shored and brought ashore for disposal.

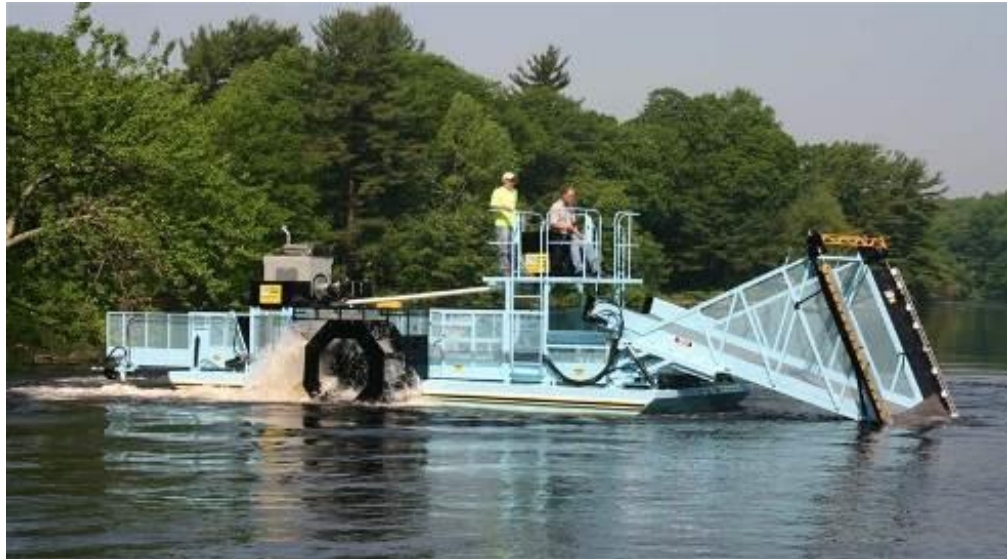
Figure 3. Harvester on the water. Photo credit: (Aquarius Systems, 2012)

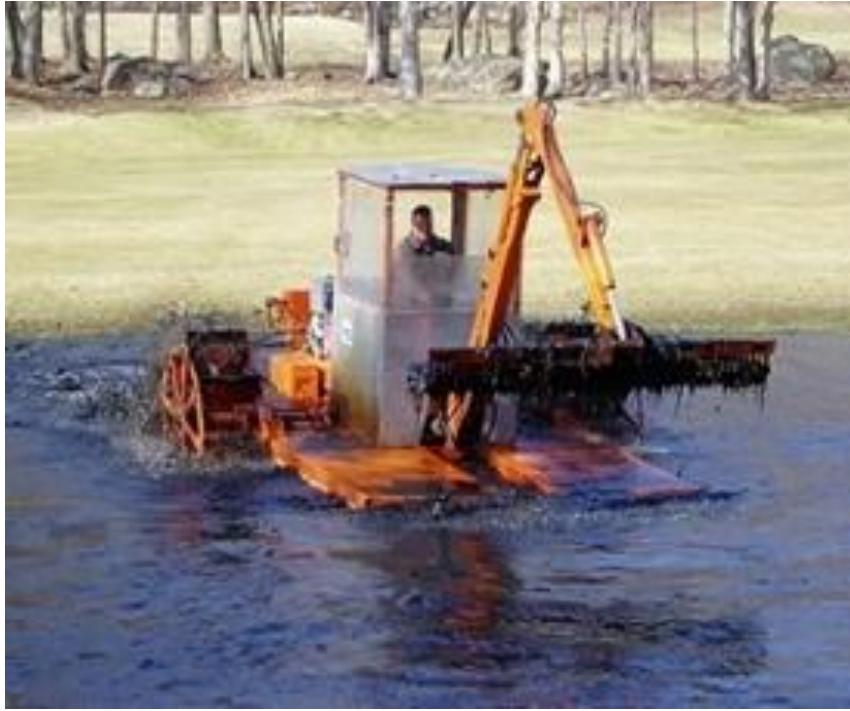
Figure 5. Hydro-rake removing plant debris from the water, showing the plastic water-guard up around the operator. Photo credit: (Solitude Lake Management, 2014a).

A hydro-rake is a pontoon boat with paddlewheels, with a large rake attached to a crane arm, operated by a seated driver, seen in Figure 5. The machinery can operate in water from one ft. (.30 m) to 12 ft. (3.65 m) (Solitude Lake Management, 2014a; The Lake Doctor, 2014). There needs to be sufficient water in the pond or lake for the hydro-rake equipment to float and work properly.

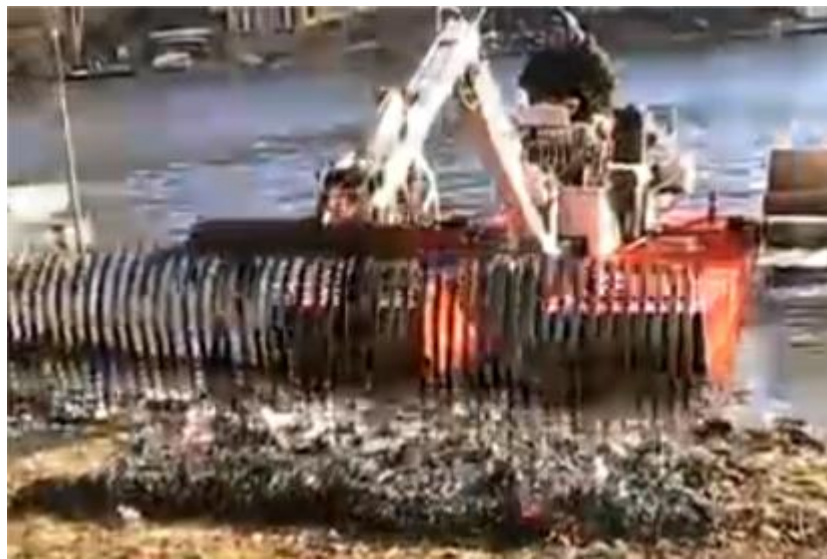
Figure 7. Video still of a hydro-rake of emptying debris onto the shoreline. Video still credit: (Taki161, 2008)

and dropped through the rake, seen as a video still image in Figure 7. Speaking with a manager who oversees hydro-raking at a pond and lake management specialty company, he described a rake attachment option with mesh sides, similar to a bucket, to remove finer sediment deposits and designed specifically so that turtles and fish can still escape when hydro-raking (J. Castellani, personal communication, March 8, 2016).

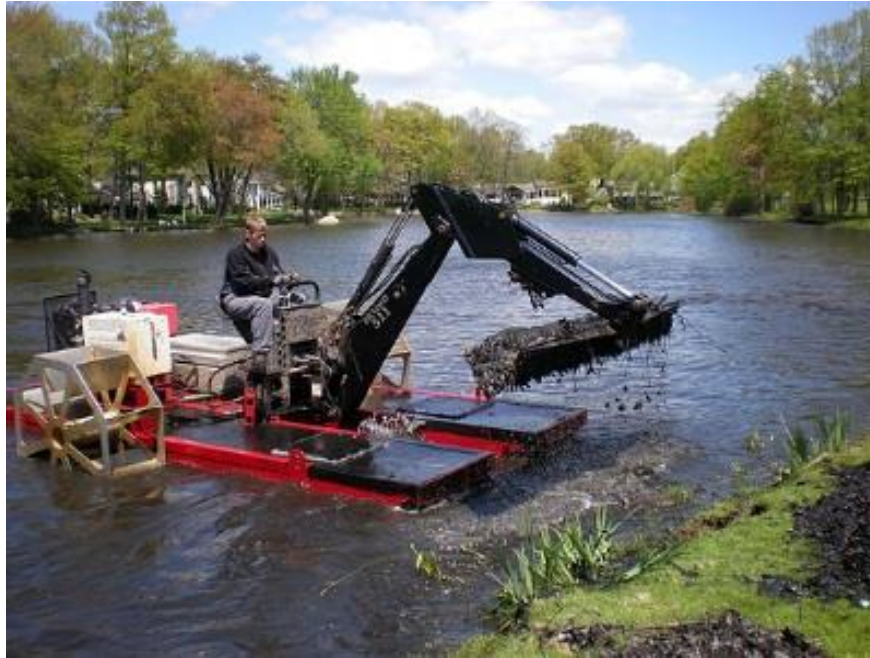
Figure 8. Hydro-rake unloading on shore. (Aquatic Technologies Inc., 2015).

Each rake, when full of debris can hold a maximum of 500 lbs. of material that can be deposited directly on-shore (Solitude Lake Management, 2014a), as seen in Figure 8.

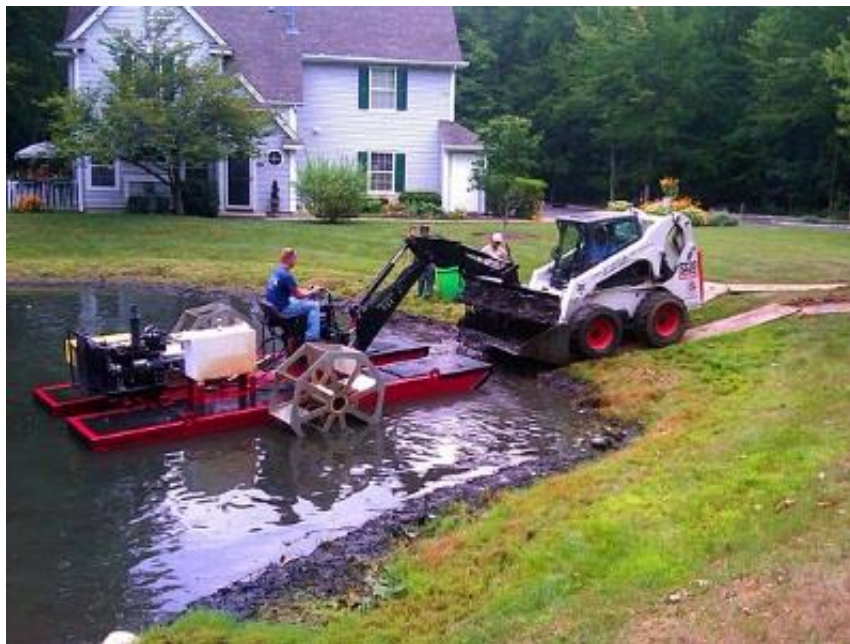
Figure 9. Hydro-rake loading debris right into a tractor's loader bucket. (Aquatic Technologies Inc., 2015)

To prevent regrowth, the plant debris must be removed from the shoreline area, and one method is to place the rakes full of debris directly onto a tractor's loader bucket for upland disposal outside the wetland area, as seen in Figure 9. That is an option to leaving the debris directly on the shoreline.

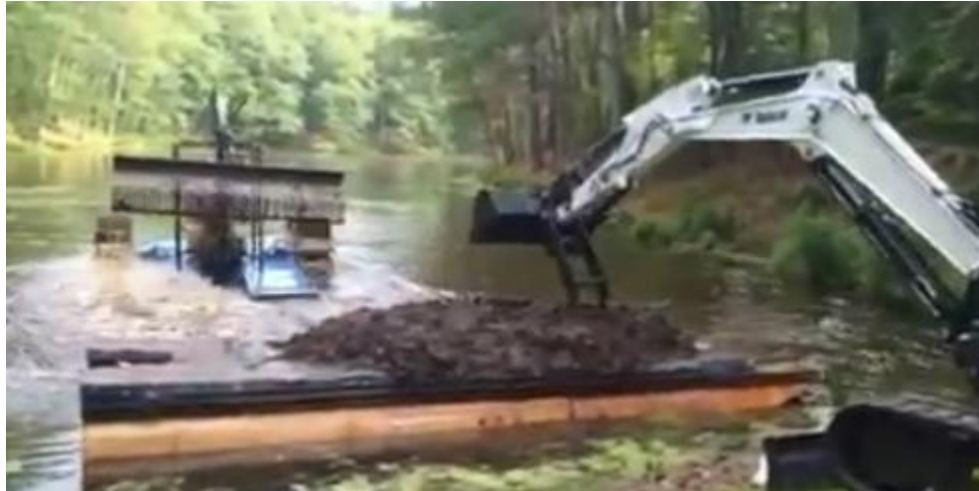
Figure 10. Hydro-rake loading debris onto a floating barge, collected by a loader bucket and placed into a dump truck bed for transport (Tom Largy, 2015).

The debris raked from the lake or pond bottom can also be placed on a barge, which functioned as a holding station, as seen in Figure 10. A loader bucket attached to a long arm, retrieved the debris off the barge to be deposited in a truck bed for transport.

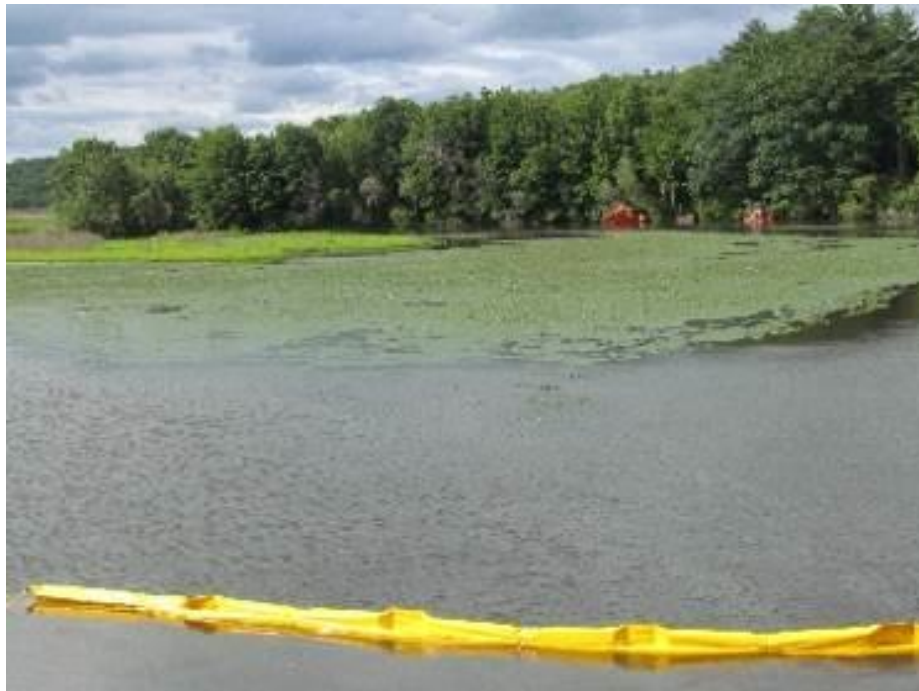
Figure 11. Fragment barrier before hand-harvesting of water chestnuts. (Blackstone River Watershed Association, 2012a)

Preventative methods are important after hydro-raking to prevent any seeds or loose plant pieces from re-growing in the sediment. Fragment barriers, seen in Figures 11 and 12 are floating buoys designed to catch any loose plant pieces or seeds and contain the fragments after the hydro-raking. The barriers in these photos were used after hand-

harvesting and a good example of before and after images of where the plant collect along the barriers. Post hydro-raking, the plant fragments and any floating seeds would cling to the buoys, which will then be collected by people on boats or kayaks.

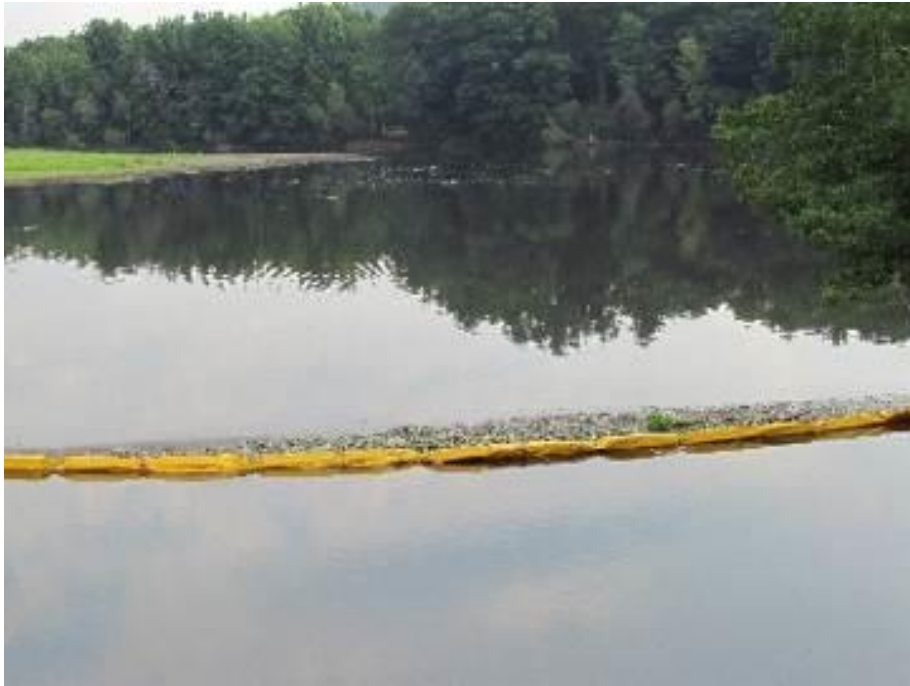
Figure 12. Fragment barrier after hand-harvesting of water chestnuts. (Blackstone River Watershed Association, 2012a)

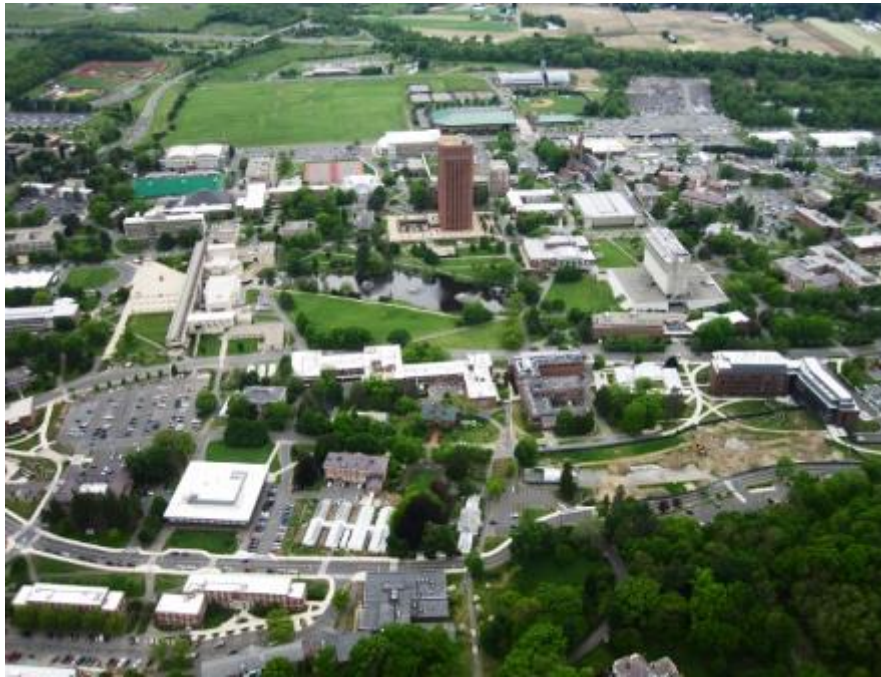
Campus Pond is located in the center of the University of Massachusetts, Amherst campus, surrounded by a large grassy lawn and many buildings. The pond is approximately 750 ft. (228.6 m) long by 250 ft. (76.2 m) wide, shown in the middle of Figure 13.

Figure 13. Campus Pond in the center of the University of Massachusetts, Amherst campus. Photo credit: (Biology Department, University of Massachusetts Amherst, n.d.).

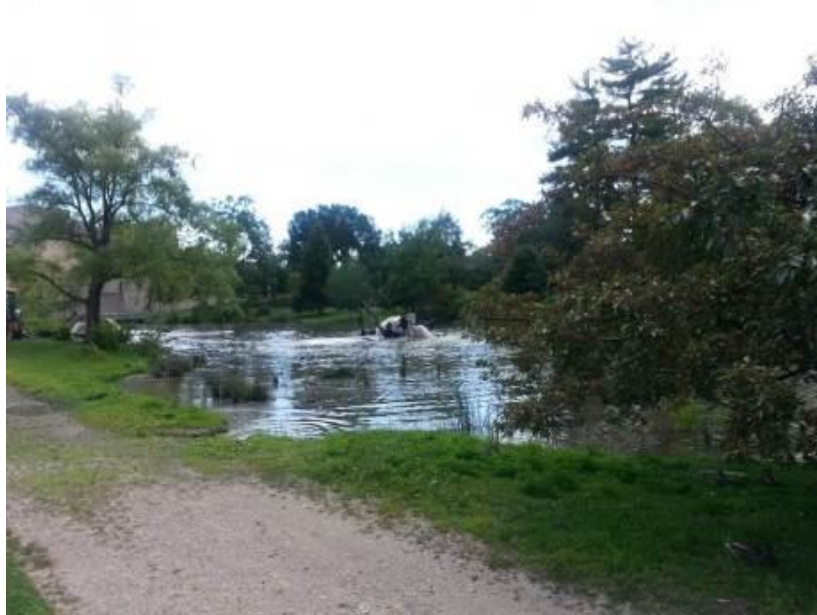
Figure 14. Two hydro-rakes working on Campus Pond. Photo credit: Danielle Desmarais.

around in a small radius, demonstrating these machines could maneuver in small places. A photo of the pond and both hydro-rake machines, seen in Figure 14, demonstrating the water being expelled high into the air.

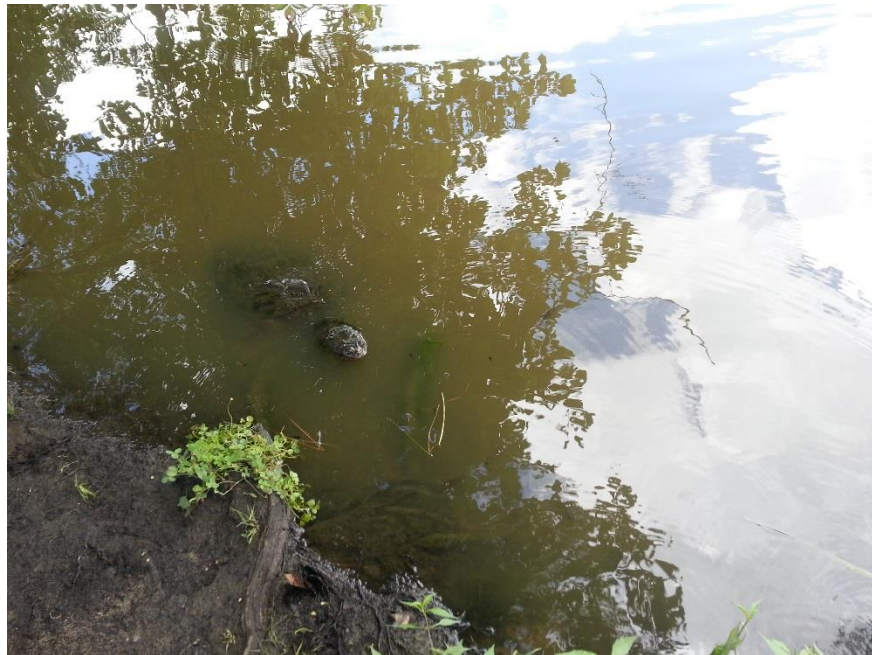
Figure 15. Two large snapping turtles hidden by shoreline suspended sediment on August 5<sup>th</sup>, 2015 during hydro-raking. Photo credit: Danielle Desmarais.

The water turbidity (cloudiness) was very high as demonstrated in Figure 15, which shows two snapping turtles, each approximately two ft. (.60 m) wide and one was barely visible directly under the surface. The color of the water, due to the suspended sediment was a light brown. Whether or not, this was the average sediment suspension level year-round was unknown.

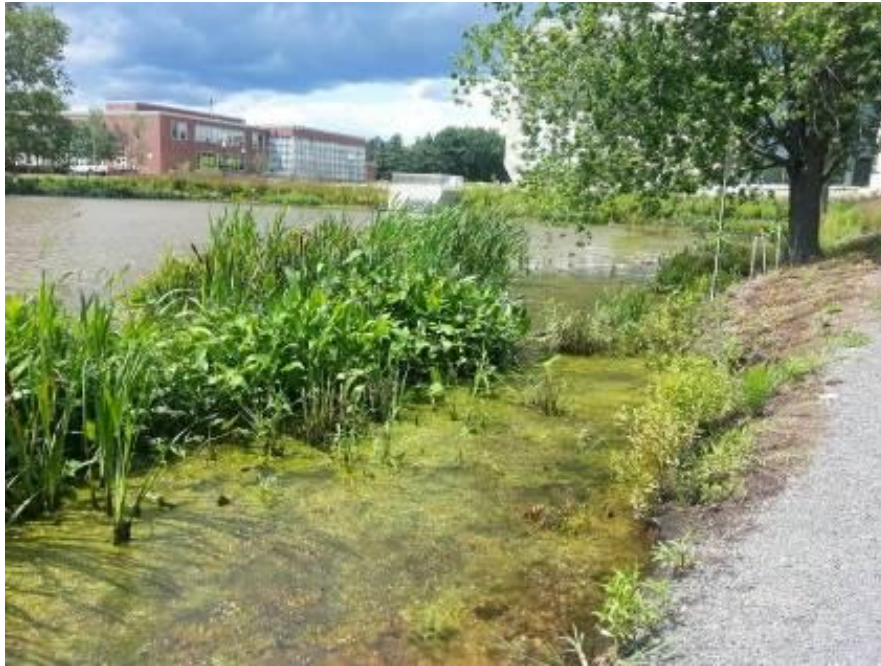
Large mats of floating aquatic plants, which appear to be algae, were seen on the surface near the east shore see in Figure 16. The hydro-rake might have had difficulty reaching that area due to the tall rushes and grasses. Those photos of the floating mats are included to show the various plant life, and visually demonstrate some of the limitations of

the hydro-rake. Algae are not recommended for removal by hydro-raking due to the ability to slip through the tines (prongs). Three hours were spent observing Campus Pond that afternoon and a hydro-rake never approached the area with the heavy floating plant mats in Figure 16.

Figure 16. Dense floating plant mats in between the shore and the emergent tall grasses. Photo credit: Danielle Desmarais

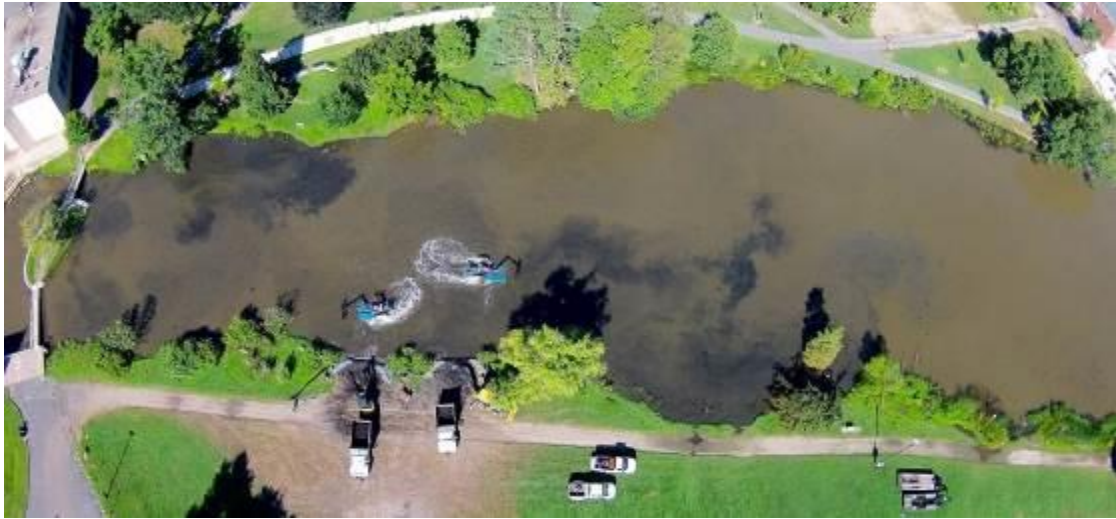
On August 6<sup>th</sup>, 2015, the next day after the my first visit to the pond, A University of Massachusetts Amherst student took the photo, seen in Figure 17 from a tall campus building, which showed the two hydro-rake machines still in operation the next day.

Figure 17. Aerial photo showing the hydro-raking of Campus Pond on August 6, 2015. Photo credit: (Kelley, 2015).

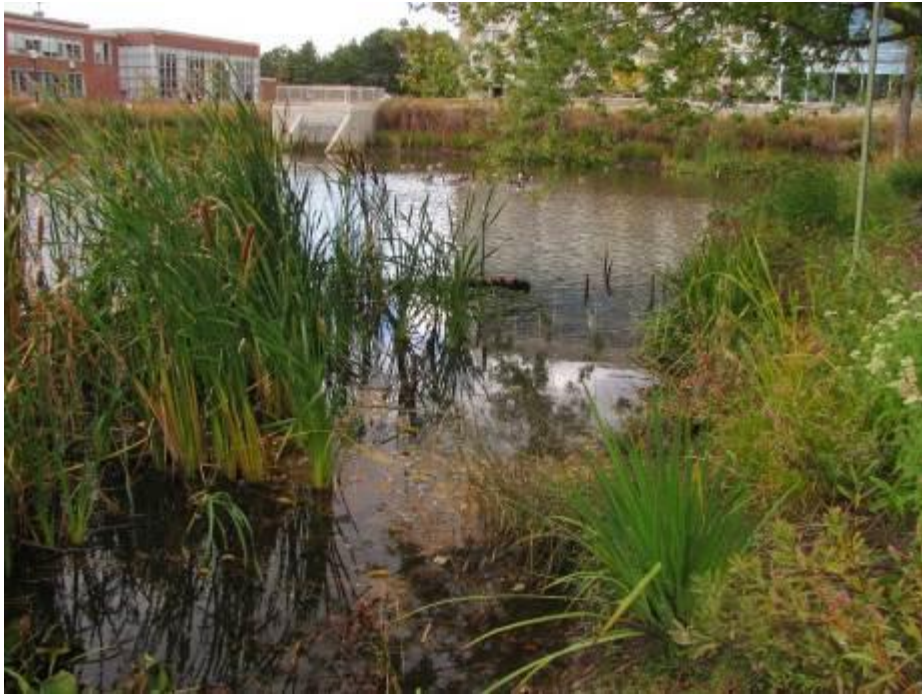
gone, and in its place were tall grasses, rushes, and flowering plants seen in Figure 18. It is inconclusive where or if the hydro-rake was able to maneuver into that tall grassy area, or if the plants died out on their own and water clarity improved.

Figure 18. Previous location of a thick mat of aquatic floating plants. Photo Credit: Danielle Desmarais

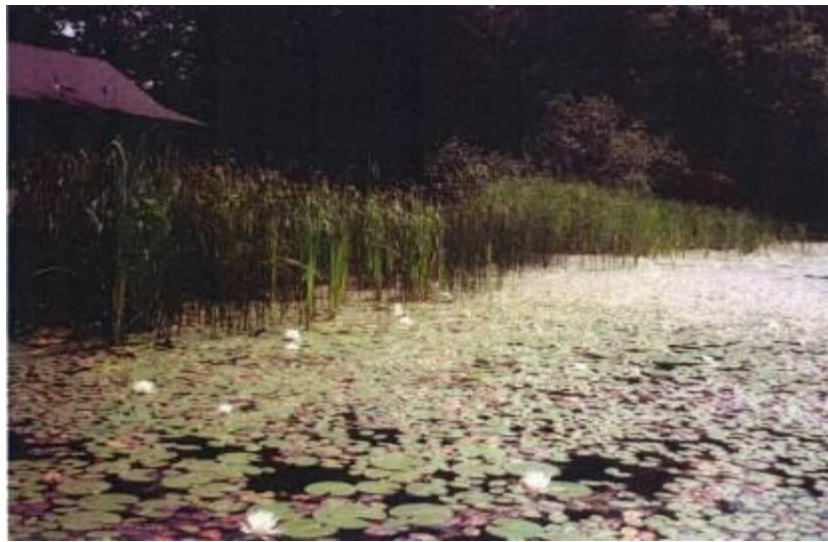
recommended, although this was not possible at Spectacle Pond due to two culverts draining into the pond and lack of a means for lowering the pond level. Therefore, manual/mechanical harvesting and/or benthic barriers were recommended as an alternative (Commonwealth of Massachusetts Division of Fisheries and Wildlife, 2008). The abundance of water lilies and cattails in August of 2008, can be seen in Figure 19.

Figure 19: Close-up of waterlilies and cattails along the shore in August, 2008. Photo credit: (Padgett, 2008).

I visited Spectacle Pond on February 21, 2016 to see the area previously cleared by the hydro-rake and mechanical harvester in August 2009, and noticed emergent plant stalks growing along the beach in Figure 21. This is the same area seen in Figure 19, which showed a close-up of waterlilies and cattails along the shore taken in August 2008, demonstrating the growth had returned in 2016.

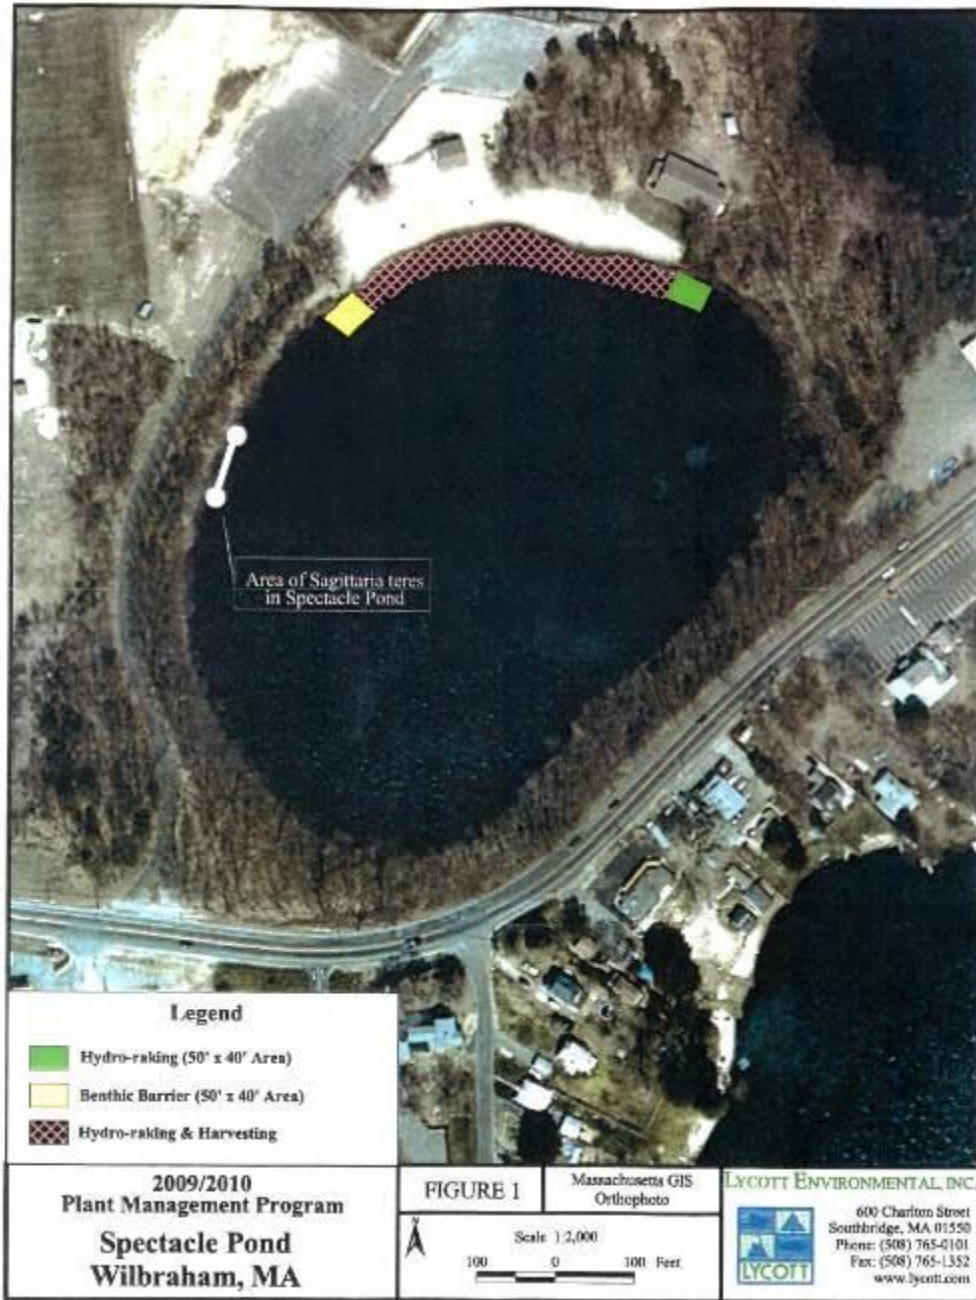
Figure 20: Management plan of Spectacle pond showing in cross-hatch the areas of hydro-raking (Lycott Environmental Inc., 2009a)

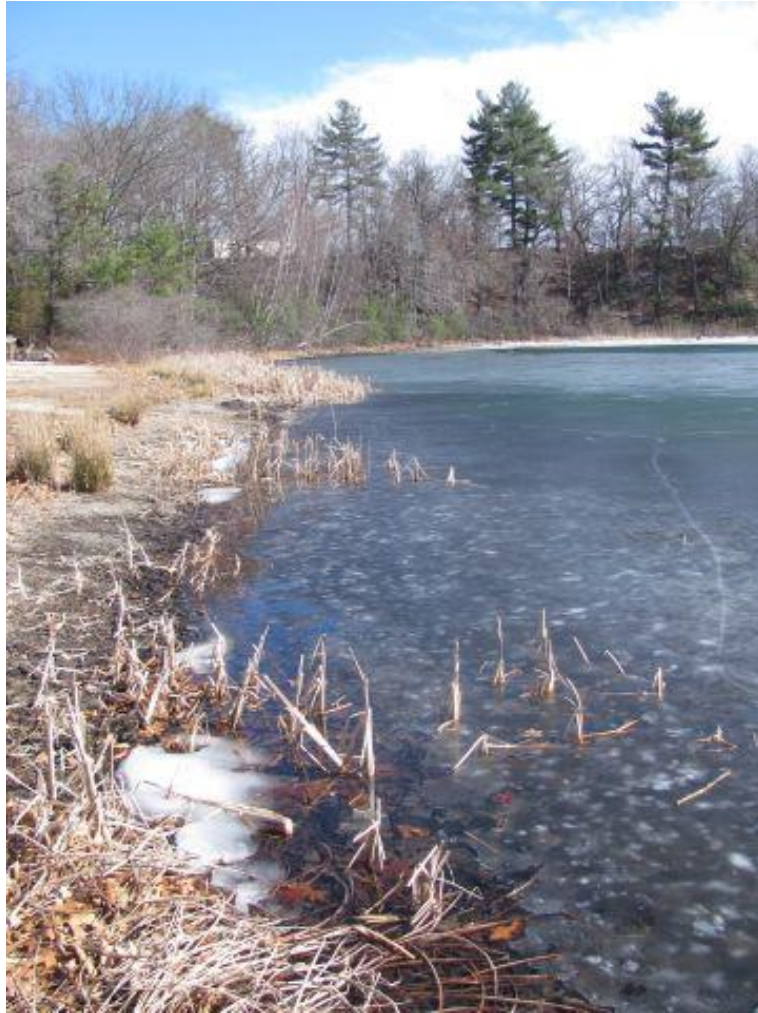
Figure 21. Emergent growth along the shore of Spectacle Pond on February 21, 2016. Photo credit: Danielle Desmarais

On March 10<sup>th</sup> 2016, a photo was taken at Spectacle Pond showing emergent cattail growth growing taller and encroaching on the beach, seen in Figure 22. This is the same location from Figures 19 and 21, and these three photos demonstrate the progressive regrowth of the emergent plants along the beach after hydro-raking had occurred.

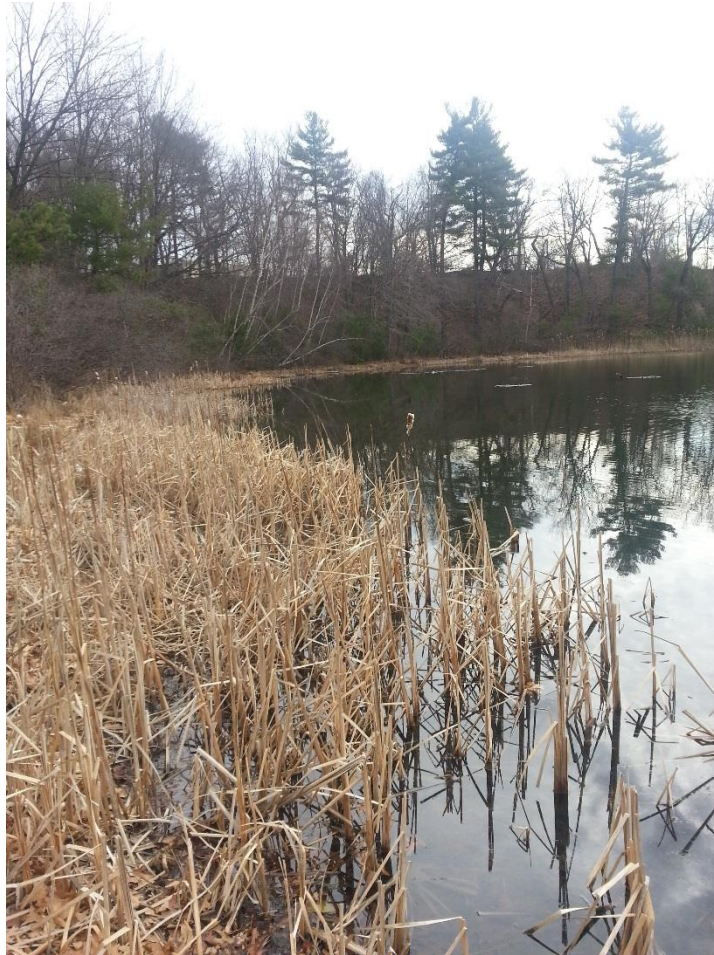
Figure 22. March 10<sup>th</sup> 2016 photo taken at Spectacle Pond showing emergent cattail growth growing taller and encroaching on the beach. Photo credit: Danielle Desmarais

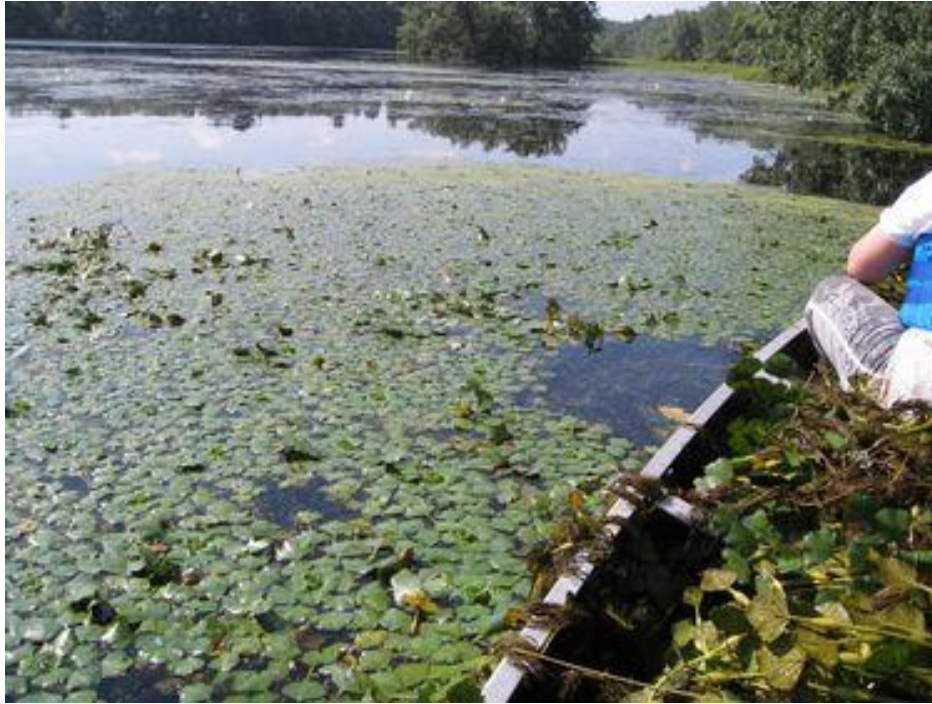
A September, 2004 environmental survey found that fanwort accounted for nearly 54% of the total plant growth in Warner's Pond seen in Figure 23, with variable watermilfoil identified in a few locations and secondary to fanwort growth, while water chestnut was being "effectively controlled" with mechanical harvesting and hand-pulling (Bellaud, 2005).

Figure 23. Abundance of water chestnuts in Warner's Pond. Photo Credit: (Town of Concord, MA, n.d)

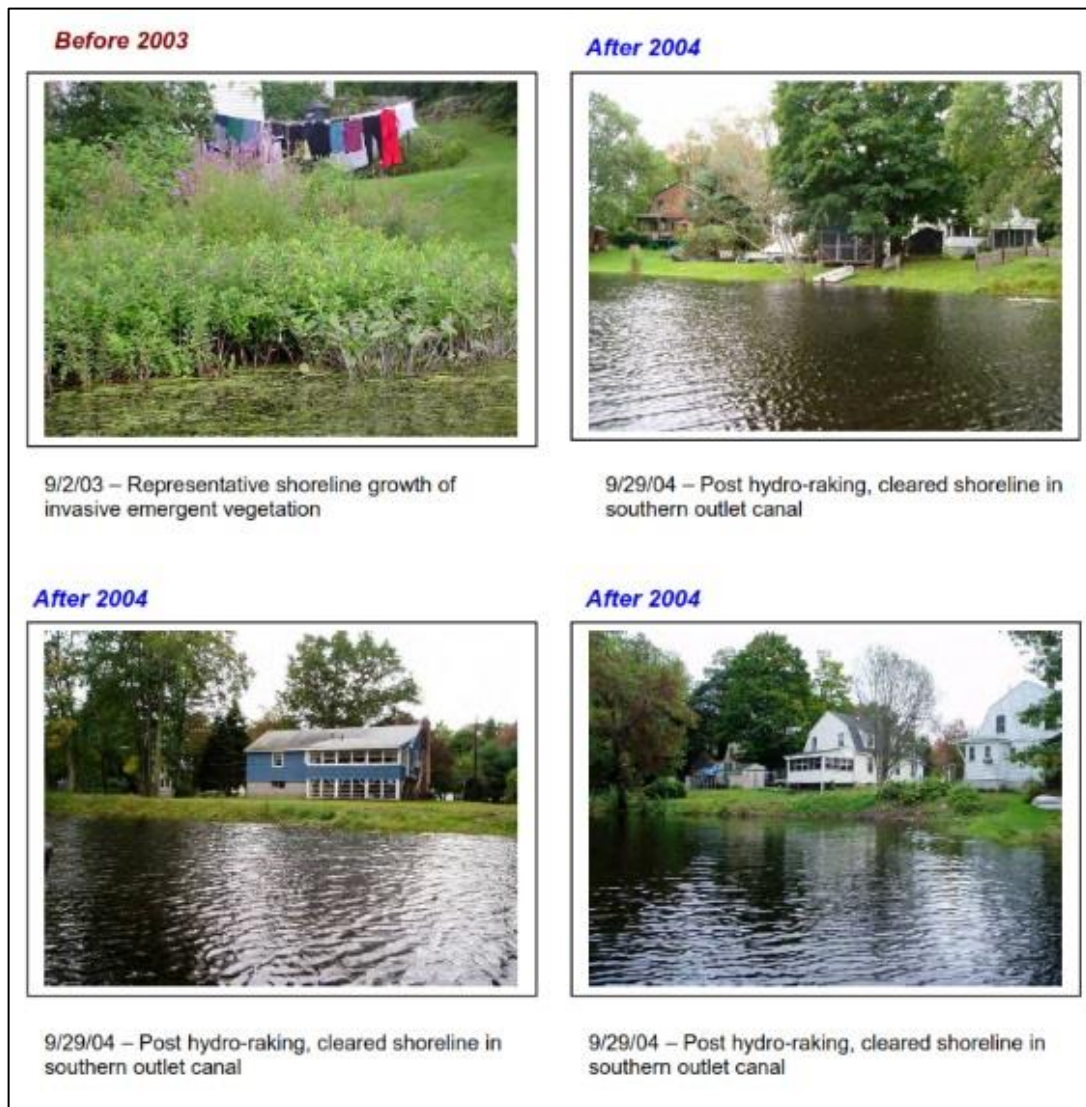
Figure 24. Warner’s Pond documentation gallery from 2003 to 2004 before and after hydro-raking. Photo credits: (Bellaud, 2005).

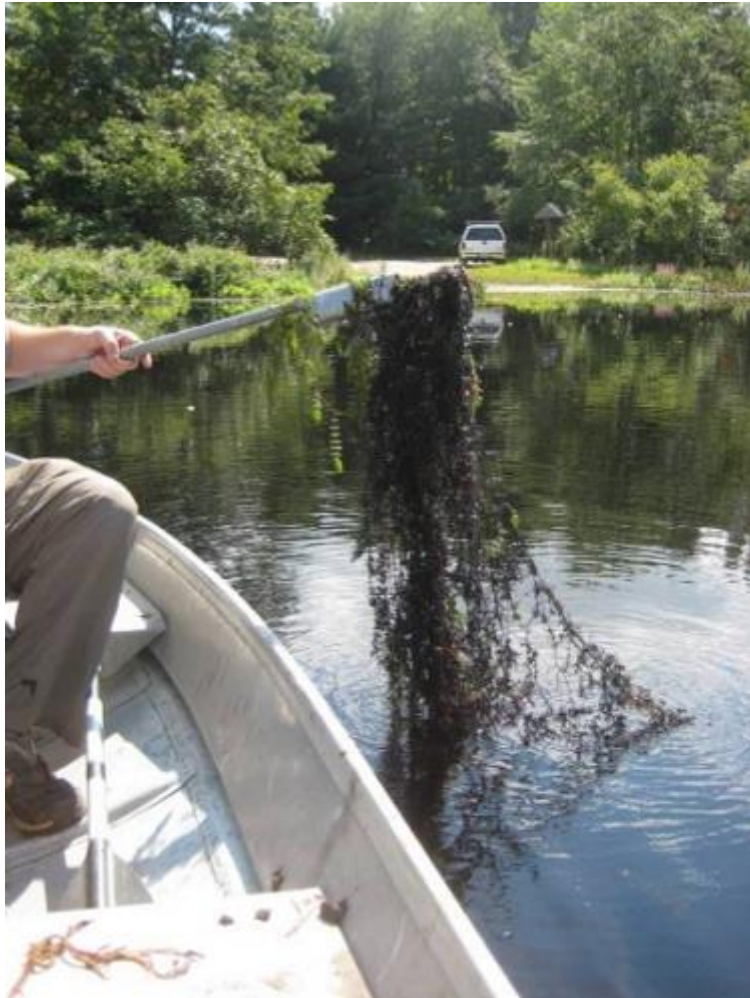
Figure 25 shows submerged plants being caught on a boat oar, demonstrating how navigating the open water could prove difficult with the presence of non-native invasive fanwort, variable watermilfoil and native nuisance coontail.

Figure 25. Photo taken on Sept 2, 2011 showing aquatic plants being pulled from the pond and onto an oar at Warner's Pond. Photo credit: (Environmental Consulting & Engineering Services Group, Inc., 2012).

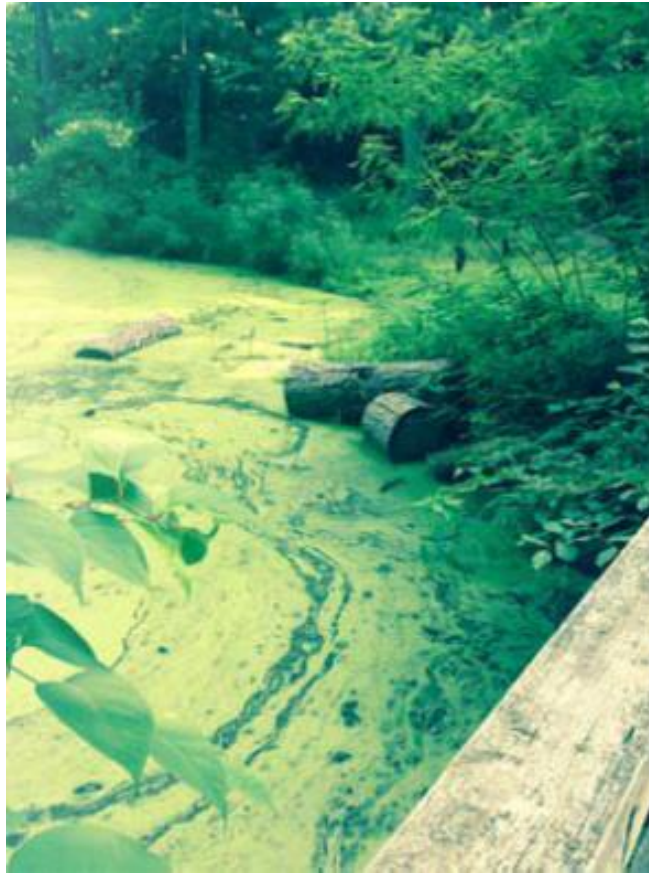
In July 2014, the upper portion of Mill Pond at the opposite end of the dam, “contained several feet of muck” (leaf litter and organic debris) before a hard bottom is reached, with approximately one ft. (.30 m) of water (Largy, 2014), which demonstrated this end of the pond is quite shallow. The middle and lower portions of the pond near the dam are approximately five (1.52 m) to six ft. (1.82 m) deep with one ft. (.30 m) or less of muck on the bottom (Largy, 2014). Three large trees, one with full leaf foilage had fallen into the pond, along with stumps and branches clogging the area above the dam, seen in Figure 26 (Largy, 2014). Figure 26 also shows the duckweed (*Lemna minor*), a native plant, distributed over the entire water surface (Largy, 2014), and often resembes and algae bloom. Duckweed is not considered a nuisance in this case study as duckweed serves as a food source for aquatic birds and animals. Due to the tiny size of the plants, duckweed would be impossible to hydro-rake, if that was ever desired for aesthetic reasons.

Figure 26. Wood debris in Mill Pond above dam in July of 2014, with duckweed seen on top of the water.  
Photo Credit: (Largy, 2014).

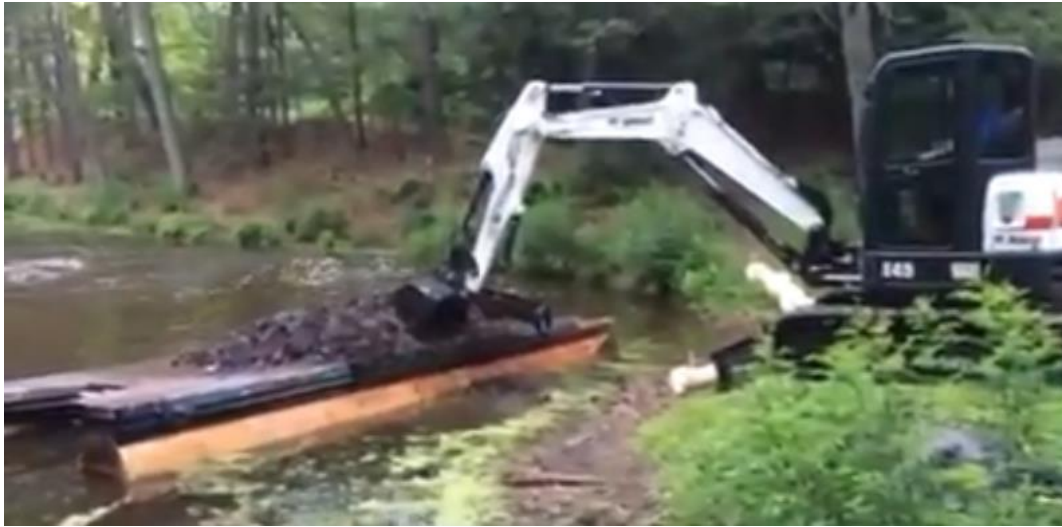
Figure 27. Video still showing the floating barge staging area near the shore. Video still credit: (Tom Largy, 2015a)

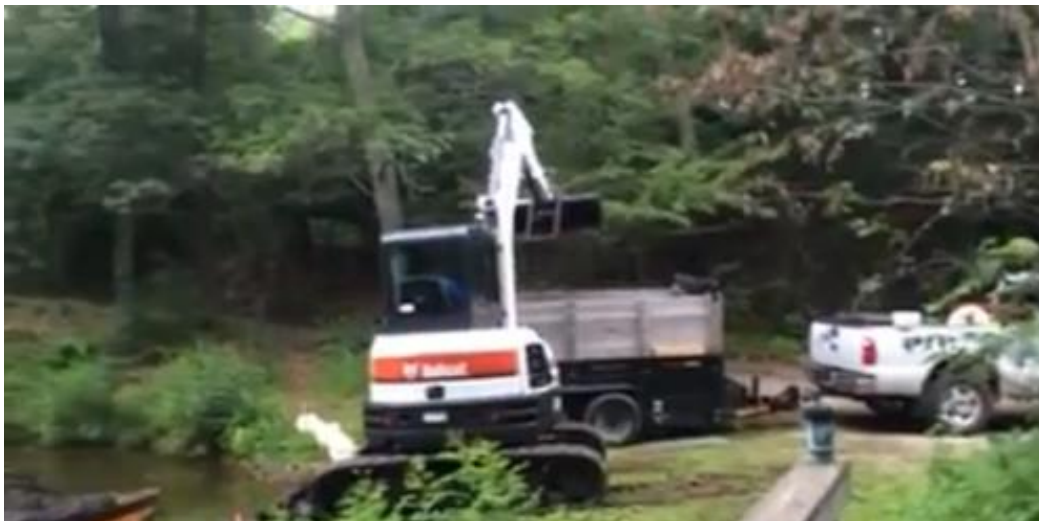
Figure 28. Video still showing plant debris removed from the barge by a loader bucket, deposited into a hauler, pulled by a truck. Video still credit: (Tom Largy, 2015a)

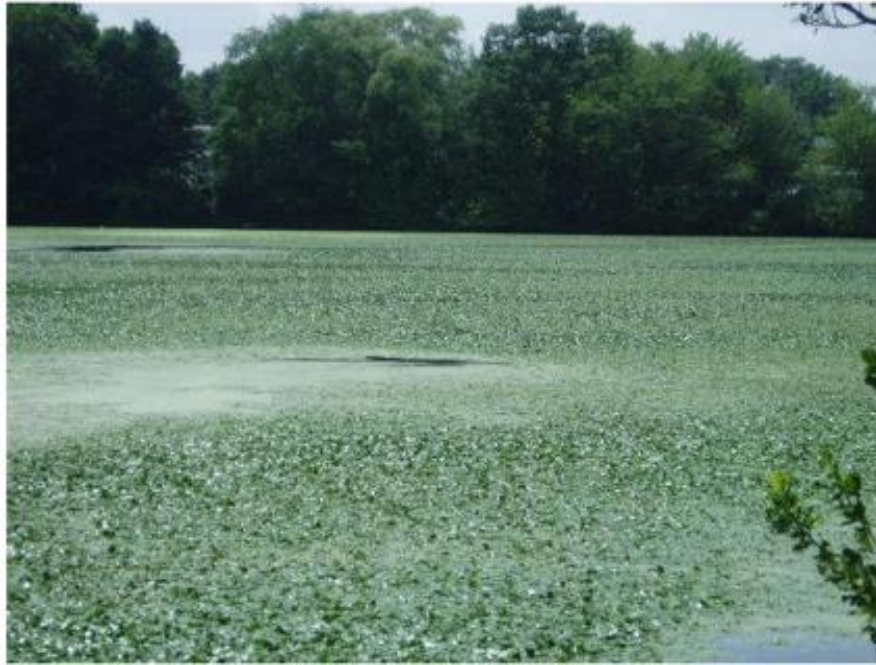
In June 2009, a survey revealed water chestnut growth inhabiting a total of 40 acres (16.18 ha) of Fiske Pond, with 24 acres (9.71 ha) of dense growth, 10 acres (4.04 ha) of heavy to moderate growth, and 6 acres (2.42 ha) total of light to trace growth (Lycott Environmental Inc., 2010). After 35 days of hydro-raking, mechanical harvesting and hand pulling around the shores, 94.4 tons of water chestnut plants were removed from the pond (Lycott Environmental Inc., 2010). It is important to note the 2009 harvest was 130.6 tons less than the previous year in 2008, meaning the volume of water chestnuts was decreasing. Figures 29 and 30, show a before and after comparison of the removal of water chestnuts.

Figure 29. Photo taken between 2007-2008 of Fiske Pond showing the abundance of water chestnuts Photo credit: (Department of Conservation and Recreation, 2010a)

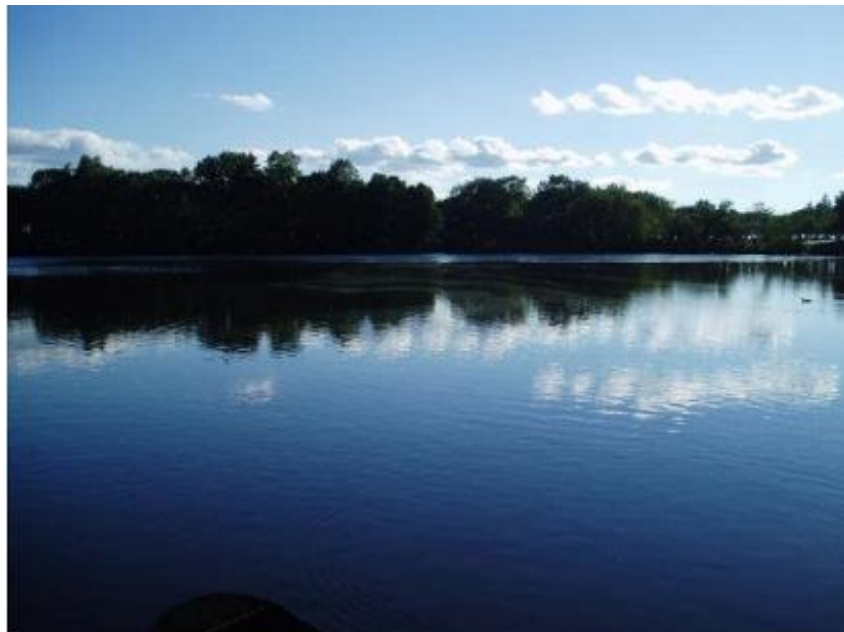
Figure 30. Photo taken between 2008-2010 of Fiske Pond after removal of water chestnuts. Photo credit: (Department of Conservation and Recreation, 2010a)

In summary, after 24 days of hydro-rake operation on Fiske Pond in 2008, 225 tons of water chestnut plants was removed, and in 2009 after 35 days of operation where 94.4 tons of plant material was removed using a combination of hydro-raking, mechanical harvesting and hand pulling. Fiske Pond saw a sharp decrease in water chestnuts from 2008 to 2009, with hand-harvesting being the only management method needed since 2011.

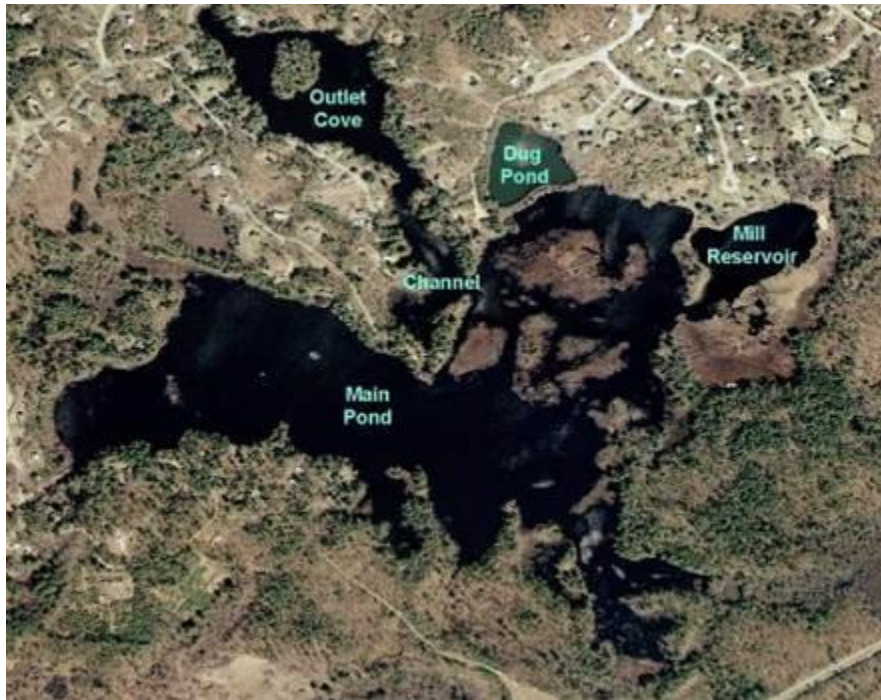
The surface area of Foster's Pond is approximately 120 acres, consists of an outlet cove, main pond, Mill Reservoir and the channel, as seen in satellite imagery in Figure 31 (ACT, 2004). Dug pond is separated from the other water bodies, and is not included in this case study due to a lack of hydro-raking for plant control.

Figure 31. The Foster's Pond system in Andover, consisting of an outlet cove, Main Pond, Mill reservoir and the channel, as seen in satellite imagery. (Foster's Pond Corporation, 2014a).

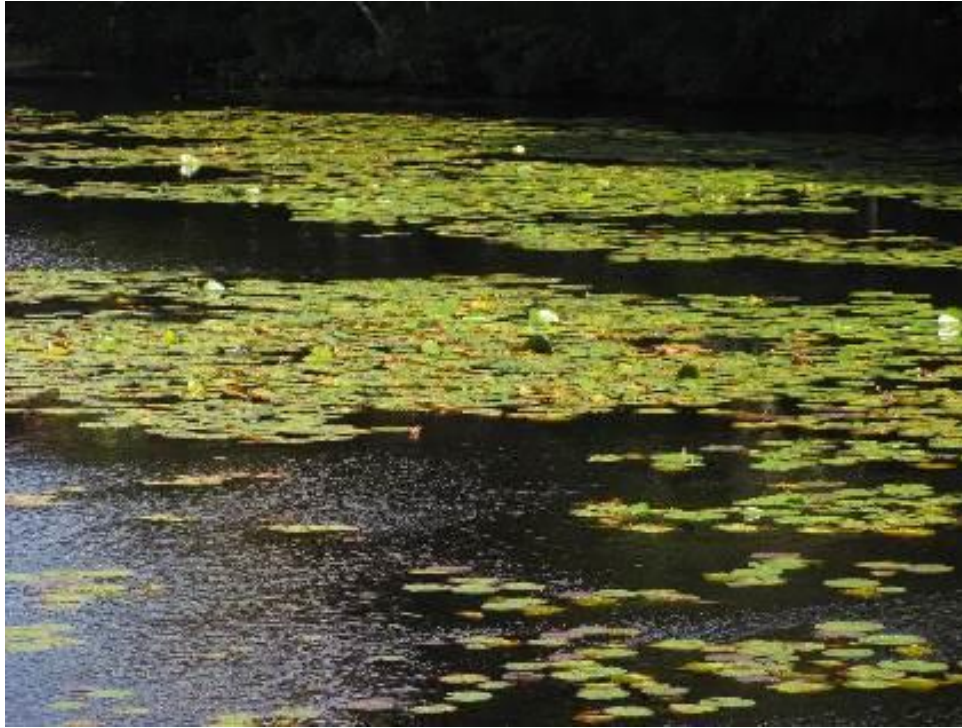
I personally visited Red Lily Pond and Lake Elizabeth in October of 2015, and I noted there were many houses along the shore in a densely habituated community, along with a fishing line hanging in a tree and a fishing buoy in the water, implying people fish at this pond. Figure 33 shows a close-up of the density of water lilies on Red Lily Pond in October.

Figure 33. Close-up of water lilies on Red Lily Pond. Photo credit: Danielle Desmarais
