# HYDRO-RAKING AS A MANAGEMENT OPTION FOR AQUATIC NON-NATIVE INVASIVE AND NATIVE NUISANCE PLANTS IN FRESHWATER PONDS AND LAKES: CASE STUDIES IN MASSACHUSETTS

**MAY 2016**

**A THESIS**

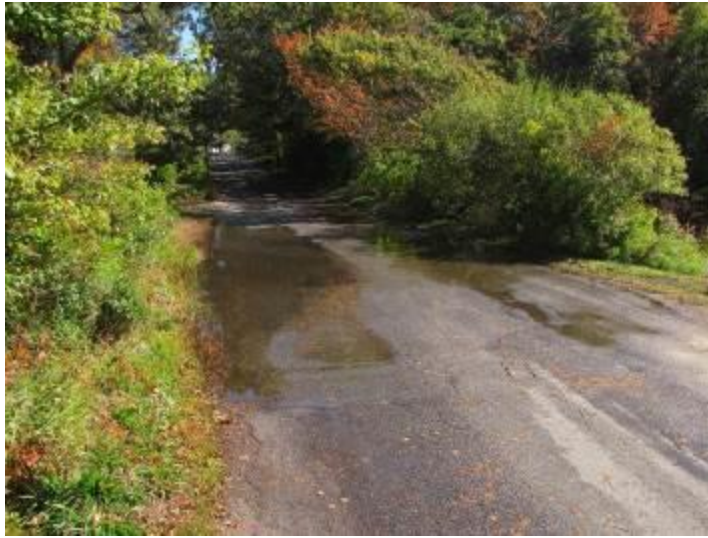
Figure 34. Road separating Red Lily Pond from Lake Elizabeth. Photo credit: Danielle Desmarais

The following Figures, 34 and 35 explain the interconnectiveness to the waterbodies because water flows south from Red Lily Pond, under a paved road, and into Lake Elizabeth through a large metal pipe. Any plants that spread through fragmentation could theoretically travel from Red Lily Pond through the pipe, and down stream to Lake Elizabeth, to start a new colony.

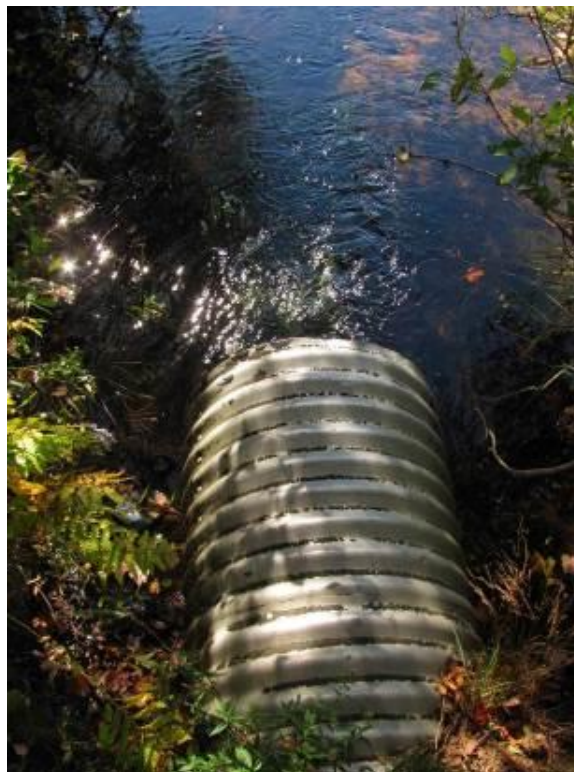
Figure 35. Large metal pipe running underneath paved road into Lake Elizabeth. Photo credit: Danielle Desmarais

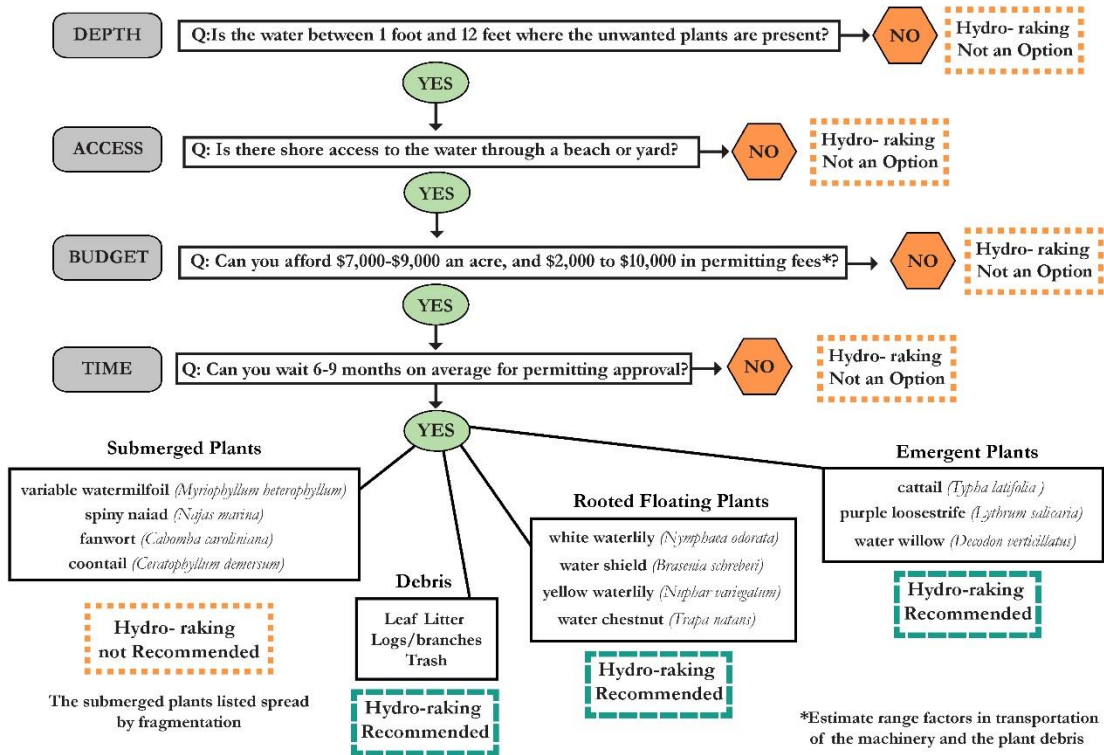
Figure 37. Decision tree to aid in hydro-raking decision making. Design credit: Danielle Desmarais
