Accelerating Anthropogenic Land Surface Change and the Status of Pleistocene Drumlins in New England

Abstract

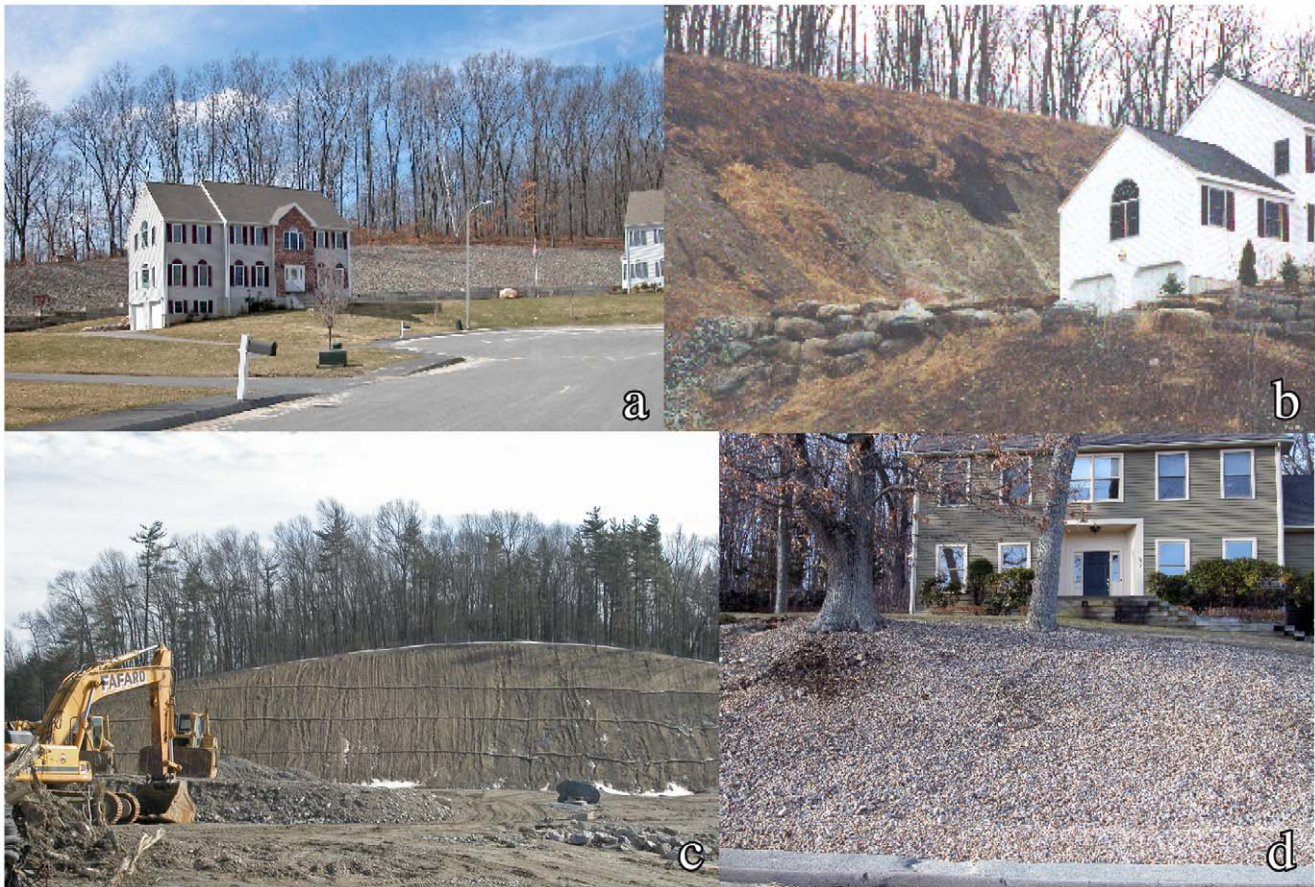
Figure 2. Drumlin modifications within the study area in eastern Massachusetts. A) An example of the large houses on relatively small lots associated with significant landform modifications. B) Slope failure on an excavated cut (Phillips Hill, Hudson). C) Large excavation of drumlin end (Indian Head Hill, Marlborough). D) Cut/fill slope on house lot (Jericho Hill, Marlborough). doi:10.1371/journal.pone.0046702.g002

two retail developments. With one exception, all date to the 1990s or after. There were also two examples of bedrock hills being significantly altered, one for single-family housing and one for multifamily housing. The excavations that are most significant in terms of material removed are three projects (Indian Head and Hager hills in Marlborough and Potash Hill in Hudson); the amount of material excavated in each of these projects is estimated at $\sim 1-1.5 \times 10^6$ m³. Excavated cut slopes reach vertical heights of 23 m and slopes as high as 36° (Table 1), a considerable oversteepening relative to the natural contours of these features (which have slopes of 15–20° on their steepest sides). Some of these excavations are shown in Figure 2.

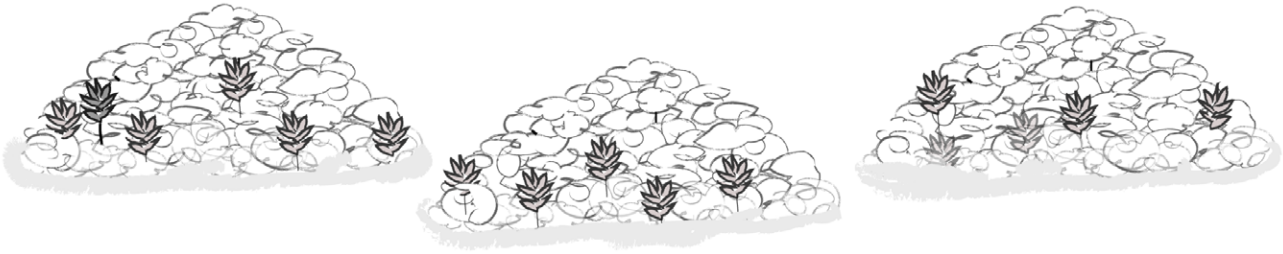
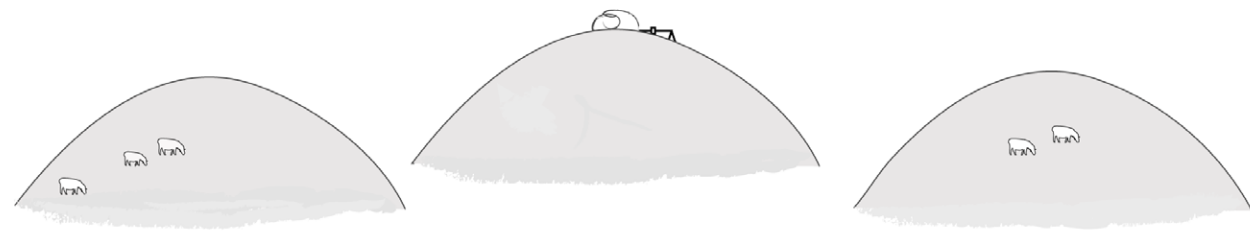
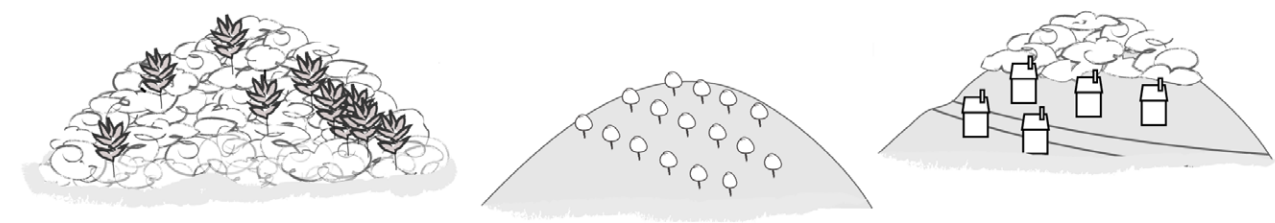
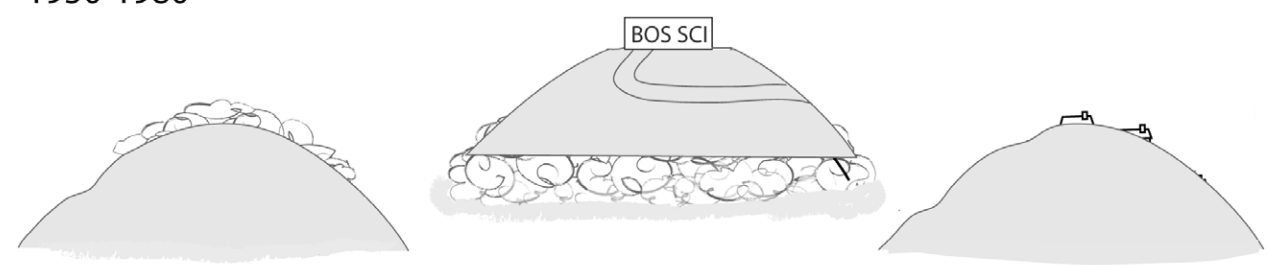
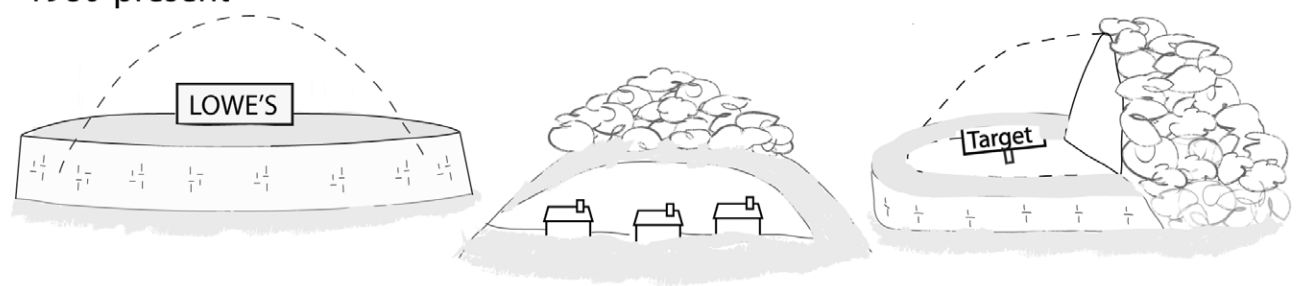
Figure 3. Diagram of the changes in eastern Massachusetts drumlins over time. See text for explanation.
doi:10.1371/journal.pone.0046702.g003

The landform alterations documented in the study area are part of the most recent chapter of changing land use in New England and can be put into the historical framework established by studies such as [7] and [8]. The following periods can be recognized (Figure 3):

1650. Prior to European settlement, extensive forests covered a glacially derived landscape with abundant wetlands and surface waters.

1850. Clearing of forests for timber, agriculture, and sheep farming starting in the colonial era [7,8] encompassed the region's low hills, including many drumlins, by the mid-1800s. During this period, drumlins were often the location of potash operations producing fertilizer from wood ashes (thus the region's many Potash Hills). In Boston, significant land-modification projects of the 1800s included filling in of Back Bay and harbor areas with material mined largely from nearby eskers [9] and grading, and in one case razing (Fort Hill), of a number of drumlins [10,11].

~1880–1920. Massachusetts' forests have been regrowing since agricultural abandonment in the mid-1800s [7,8]. By ~1920, many area drumlins were becoming reforested. Orchards were also established on the tops and sides of drumlins [12], which are still considered ideal for this purpose [13]. In some areas of high

1950–1980. Starting around 1950, housing developments were established on some drumlins where slopes permitted (typically involving some degree of grading and levelling). Excavations for the Massachusetts Turnpike in the 1950s also involved shearing off the top of at least one drumlin (The Mountain in Framingham [14]) and significant excavations of others.

1980-present. The first examples of corporate offices and office parks being established on the tops of drumlins date to the High-Tech boom that started in the 1980s - notably Lucent Technologies and Boston Scientific on Addition Hill and 3-Com on Crane Hill (Marlborough) and Bose Corporation on The Mountain (Framingham). The significant alterations documented in this study - high cut and fill slopes and levelling to create flat plots - have been occurring since around 1990.
