**Reducing the Risks of Highly Enriched Uranium at the U.S.
Department of Energy's Y-12 National Security Complex**

October 9, 2006
**REDUCING THE RISKS OF HIGHLY ENRICHED URANIUM AT
THE U.S. DEPARTMENT OF ENERGY'S Y-12 NATIONAL
SECURITY COMPLEX**

by
Robert Alvarez
Senior Scholar
Institute for Policy Studies

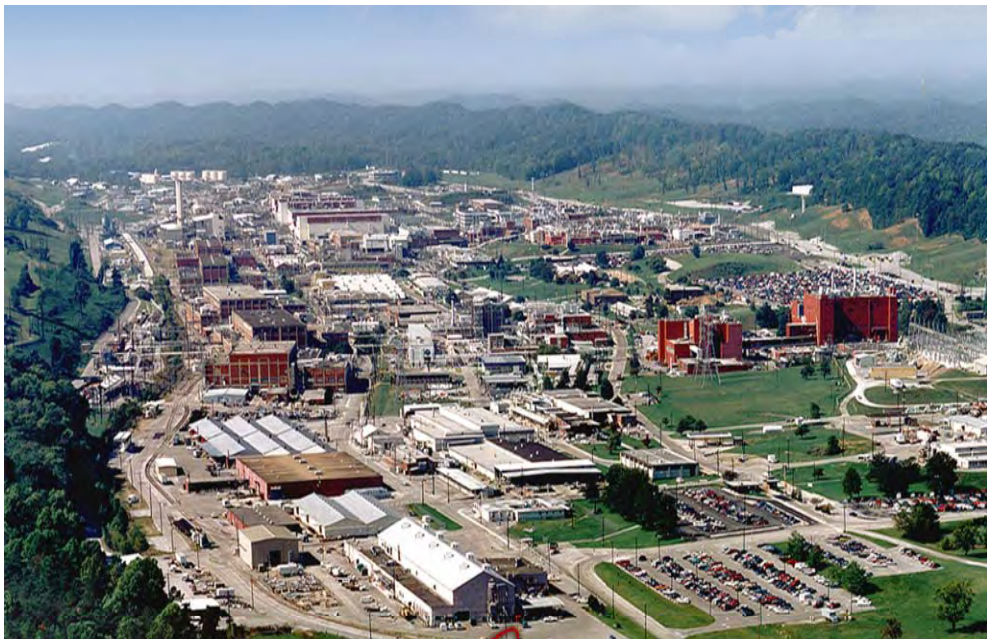
Figure 1 The Y-12 National Security Complex

Knoxville, TN. (See Figure 1.) Its primary mission at the time was to produce sufficient quantities of Uranium 235 for the Hiroshima weapon. During this period some 40,000 people were employed to operate electromagnetic separations facilities (Calutrons),⁷ designed by Ernest O. Lawrence and his team at the University of California. (See Figure 2) Between 1943 and 1947, large quantities of uranium oxides were converted into Uranium chloride (UCL₄) and then were processed in two stages using calutrons housed in nine large structures.

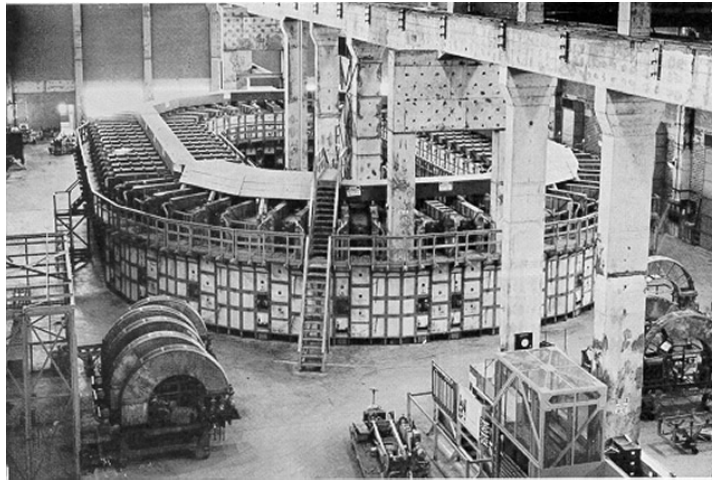
Figure 2 Electromagnetic Separation Process Equipment at the Y-12 Plant (1943-1947)

*"By any scale, the operation there was mammoth."*⁸ Two 500-tank calutron "race tracks" were installed *"each measuring four football fields long."*⁹ By 1946, the mission to enrich uranium was shifted to the Oak Ridge K-25 Gaseous Diffusion Plant, sharply curtailing the calutron operations, which were used in subsequent decades to produce isotopes for research. Between 1944 and 1951, the Y-12 operation was focused on recovery and salvage of U-235 in calutron equipment and feed material. (See Figure 2)

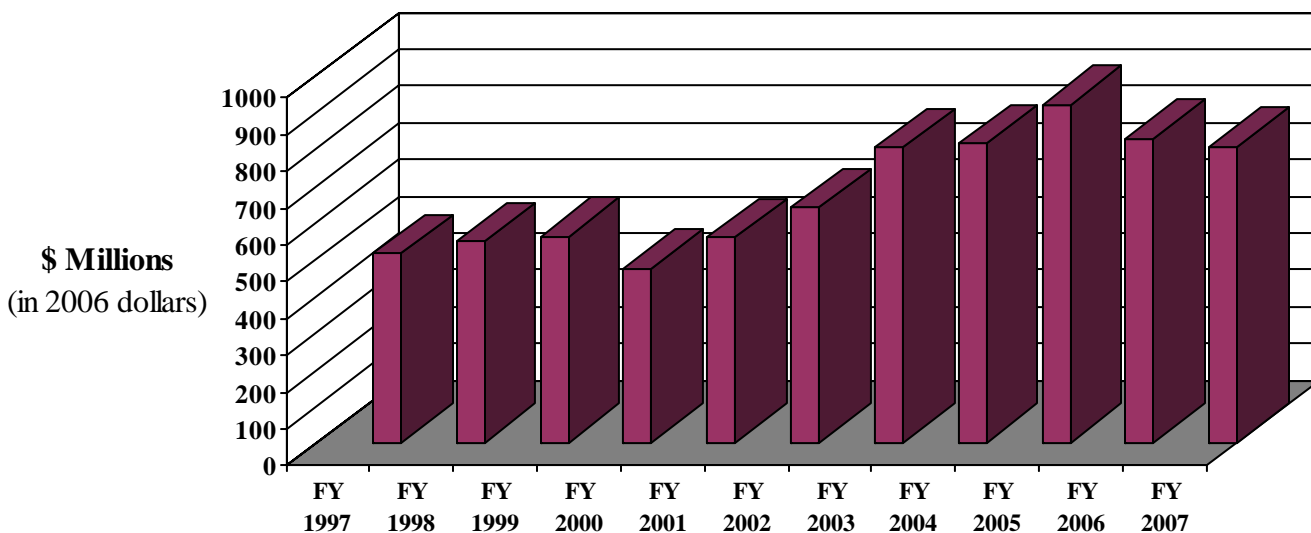
Figure 4 Annual Budgets for the Y-12 Site

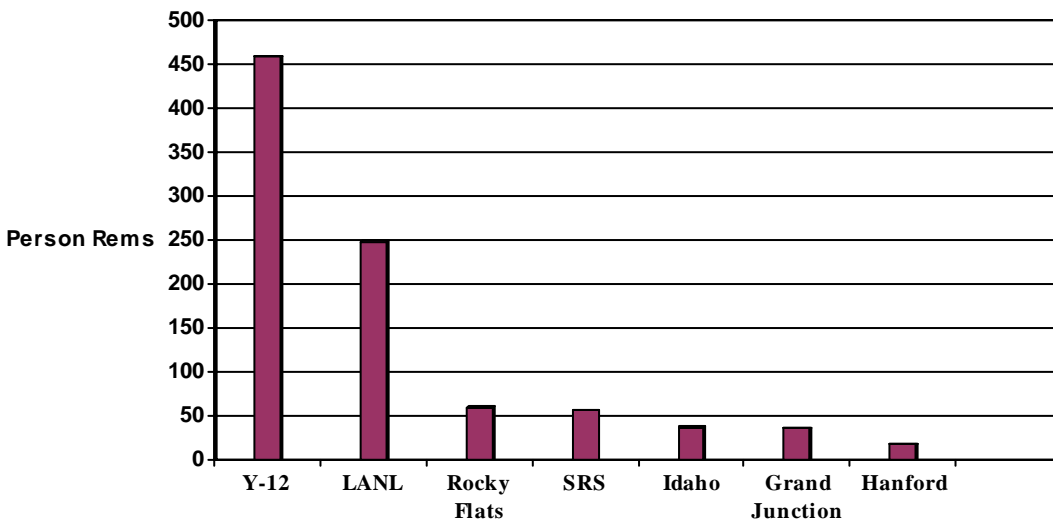
Figure 5

Internal Radiation Exposures to DOE Workers (Committed Effective Dose Equivalent)

Risks of internal radiation exposure are the highest at the Y-12 site than any other DOE site. (See Figure 5) More than forty percent of the total collective internal radiation dose received by workers in the DOE complex has occurred at the Y-12 Complex, since the early 1990's.⁵² Contamination of the workplace and outside areas in the western portion of the Y-12 site from more than 60 years of production remains a problem. (See Appendix B)

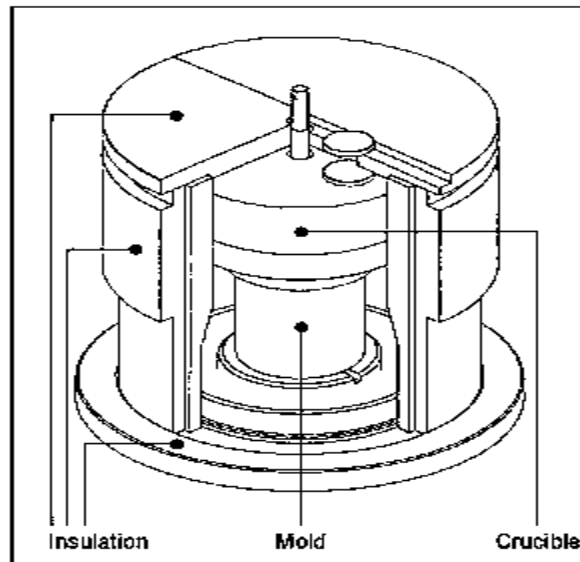
Figure 7 Microwave Crucible

“a multimode microwave cavity, a microwave-absorbing ceramic crucible and a thermally insulating casket that is microwave-transparent. The metal charge is placed in an open (no lid) ceramic crucible, and the insulating casket is positioned to completely cover the open crucible. The casket and crucible assembly are placed into a high-power multimode microwave cavity capable of uniformly heating the crucible to the desired temperature. Microwave energy applied to the cavity is strongly absorbed by the crucible. The metal charge in the crucible is quickly heated by means of radiation, conduction and convection with the heated crucible walls. The thermally insulating casket increases the energy efficiency of the microwave system by trapping the heat generated in the crucible. (See Figure.7).¹⁶⁴
