**CONTAMINANT PLUMES OF THE
LAWRENCE BERKELEY NATIONAL
LABORATORY AND THEIR INTERRELATION TO
FAULTS, LANDSLIDES, AND STREAMS
IN STRAWBERRY CANYON, BERKELEY AND
OAKLAND, CALIFORNIA**

March 2007

Laurel Collins, Geomorphologist
Watershed Sciences
1128 Fresno Ave
Berkeley, California 94707
collins@lmi.net

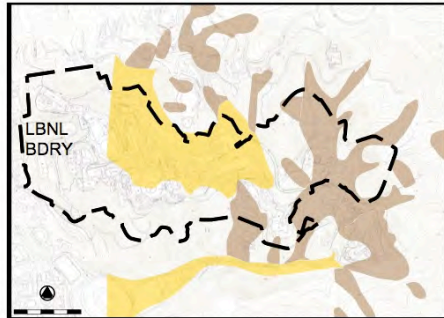
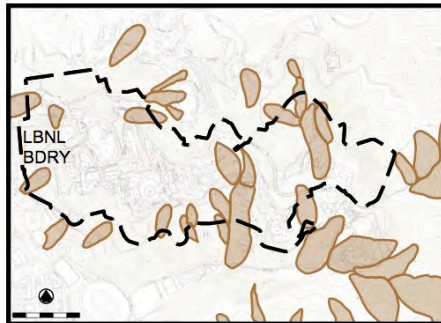
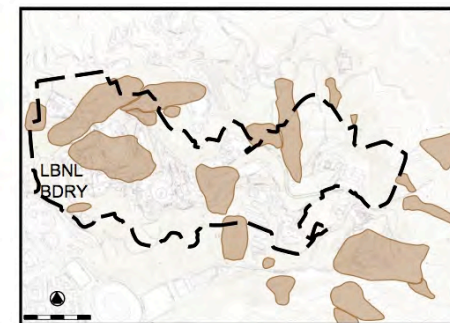
FIGURES 13a-13e. MAPS OF LANDSLIDE STUDIES AND SURFICIAL DEPOSITS GEOLOGY

13a. Tor Nielsen, 1975 (USGS)

13b. LBNL, 2000

13c. Unpublished, Received from Kropp Assoc. (no author or date).

13d. Unpublished, Received from Kropp Assoc. (no author or date).

13e. California Geological Survey, 2003

Additionally, some maps group colluvium with fill, such as Figures 13a and 13b. Nonetheless, we expect that the brown polygons on map Figures 13a through 13e and the brown and purple ones in map Figure 13f all represent shallow to deep-seated landslide failures. Using historical and recent aerial photographs, the landslide features in Figure 13f were specifically mapped for this project and the slides therefore, are mapped relative to the historical topography and channel network as per Figure 5.

The deep-seated slides in Strawberry Canyon, shown in Figure 13e and 15, in most cases tend to be slumps, earthflow, or complex earthflows that can involve movement of large intact blocks of bedrock and extend from ridge top to valley bottom. The complex slides can be characterized by multiple failure planes and zones of stability and instability that change after the mass balance is altered by renewed activity or by man-made changes during grading operations. In many cases, there is rotational movement near the crown scarp and the entire mass can slowly creep or move in sudden surges. These kinds of slides are often associated with clay-rich earth or bedrock. Perched water tables at the rotated head of the deposit can be common. Similarly, springs can typically be found where the failure plane near the toe of the slide verges toward the ground surface and converts its subsurface flow to overland flow. If contaminant plumes intersect landslides and travel along landslide failure planes, surface waters within seep gullies on the landslide or at the toe of the slide could also be at risk of contamination.

Shallow landslides in Strawberry Canyon, shown in Figures 13e and 15, tend to be soil slips, debris slides, and debris flows, which typically occur on steep slopes and move typically at high rates of speed. They tend to be translational in movement and are often associated with soils or bedrock that is porous and not necessarily clay-rich. They often occur within colluvium-filled hollows. The debris flows can form alluvial fans at the base of their run-out pathways.
